CIGRÉ Regional Meeting
August 27-28, 2007, Calgary, Canada

ASSESSMENT OF ELECTRICAL AND MECHANICAL PERFORMANCE OF TOUGHENED GLASS INSULATORS REMOVED FROM EXISTING HV LINES

J.M. GEORGE*
SEDIVER FRANCE

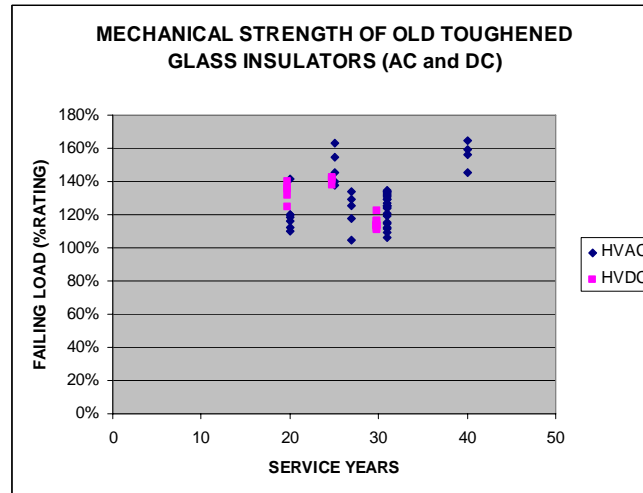
Figure 1: Normalized test results as a percentage of the insulator nominal rating (Initial rating of the new insulator is 100%)

These tests were performed according to IEC 60383. The mechanical failing load was determined on about 40 samples from the different field cases as shown in appendix A. Given the fact that all insulators are not rated at the same value, the summary presented in figure 1 shows a normalized presentation of the test results compared to their ratings. It is clearly established here that all the values are above rating and that there is no evidence of time dependence.

Appendix A and figure 1 describe the mechanical normalized results as a percentage of the rating. It appears clearly that, like for AC, there is no degradation over time.

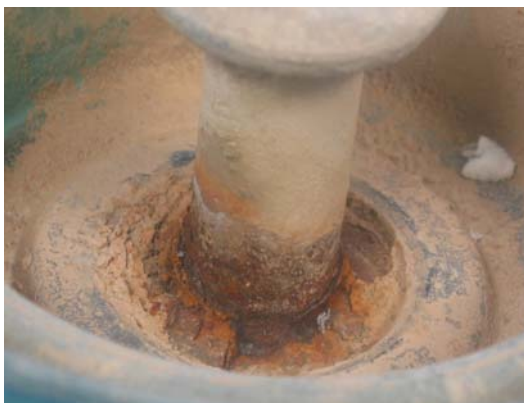
Figure 2: Pin corrosion after more than 20 years in service in severe condition (Iran)

Some insulators had severe corrosion on the shank of the pin. Those correspond to some of the lowest (but still above rating) test values found during this evaluation. These were units in service in extreme contamination conditions as shown in figure 2. This phenomena is known as a major contributor to the end of life of cap and pin insulators. Over the last 25 years, however, major manufacturers started supplying the insulators intended to be installed in corrosive or highly polluted conditions with a pin protected by a zinc sleeve on the shank (shown in figure 3) which eliminates completely such degradation with time.

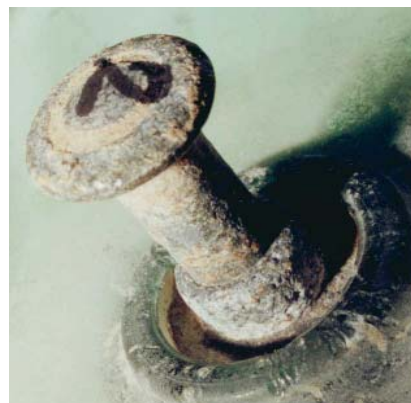
Figure 3: Zinc sleeve protection preventing and eliminating pin corrosion

- Under extreme corrosion conditions, old insulators can have suffered of pin corrosion. A mechanical strength reduction may result under extreme conditions. This particular point of performance has been solved more than 20 years ago by the addition of a sacrificial pure zinc sleeve attached to the shank of the pin. This protection has completely eliminated the occurrence of such pin corrosion.
- The dielectric itself has shown no sign of ageing. Neither mechanical nor electrical weakening has occurred up to an excess of 40 years. These insulators have been exposed to harsh pollution, including particular stresses such as DC ionic migration conditions.

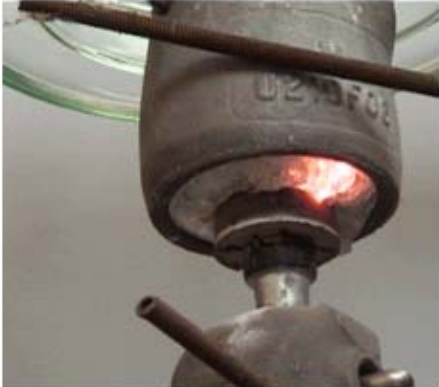
Figure 4: arc remains outside on a broken glass insulator (also called “stub”)

Residual electrical strength of stubs have been evaluated under dry power frequency conditions, and a withstand value around 12kV to 20kV was established. As shown in figure4, the arc is always outside the stub, eliminating the risk of internal arc.

These results demonstrate that a broken glass insulator does not represent a threat to the line, because it maintains a high mechanical strength with no risk of internal electrical puncture. This is an essential difference compared to porcelain which, once damaged can lead to all types of erratic behaviours (including string separation) and therefore requires quick intervention of maintenance.

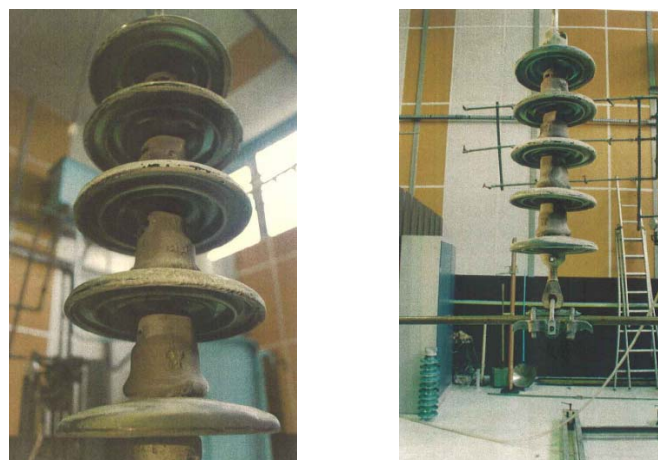
Figure 5 : Electrical type tests on BS1513 insulators after 27 years of service on a 132kV line in Malaysia.

As can be seen in [figure 5](#), type tests have been performed on a variety of those insulators, and results are in line with specified values. The particularity of the toughened glass dielectric is that cracks cannot propagate inside the glass given the toughening condition of the glass (see section 4). Therefore, there is no possibility to find a punctured unit made of toughened glass, and subsequently results are all in line with the electrical ratings (dry/ wet power frequency and lightning impulse).

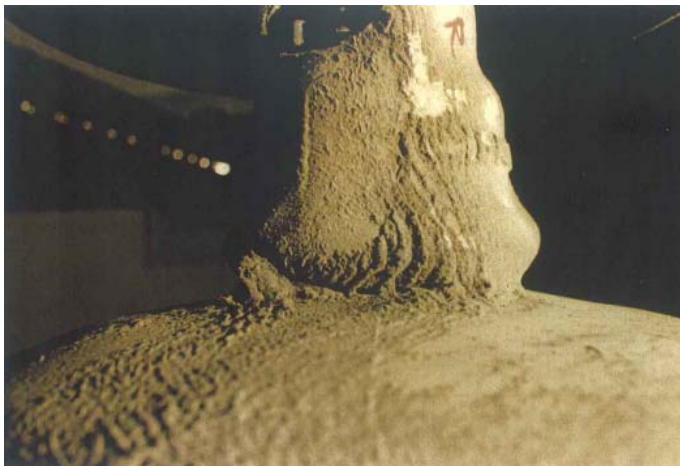
Figure 6: Pollution condition of a 27 year old glass in Malaysia. (near cement plant)

In addition to these type test verifications, an additional pollution test was performed on a string which also came back from Malaysia (line Rawang-Who). As can be seen in [figure 6](#), the level of pollution was extraordinary high. [Table 3](#) give the contamination measured on these units:

ESDD mg/cm^2	NSDD mg/cm^2
Top surface	0,077	24
Bottom surface	0,06	29

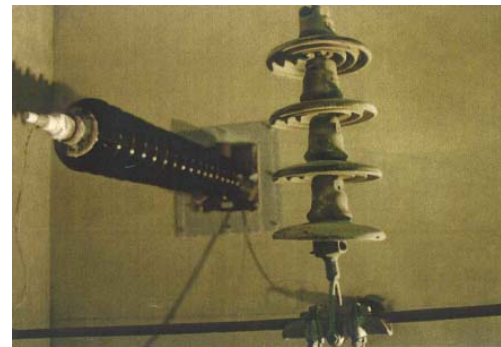
Figure 7: view of fog chamber insulator during the pollution test

A pollution test according to IEC 60507 was performed ([figure 7](#)). A withstand value of $15\text{kV}/\text{unit}$ (phase-ground) was determined. This value confirms that after 27 years in service on a 132kV line, the string was still capable to operate normally despite the extreme level of NSDD covering the surface.

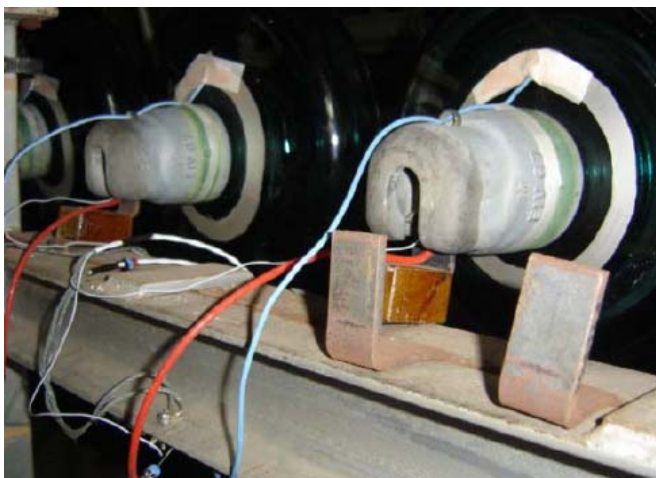
Figure 8: ionic migration set up

After about 30 years in service, these insulators were tested according to this procedure which is set to describe a 50 year ionic activity. After measuring the body resistance, test parameters were adjusted to set the conditions as if the test was performed on new insulators. (Figures 8 and 9). Test conditions were 70kVDC and 90°C

The equivalent to 50 years would correspond to an accumulated charge of 153C. At this point nothing happened during the test, and all the insulators were still intact. The test was continued until an accumulated charge level reaching an equivalent of 100 years with only one shattering occurring around the 86 year mark. This, with the already 30 years of field service demonstrates the reliable performance of glass, far beyond the normal expected lifetime of the transmission line and under especially harsh conditions such as DC operation.

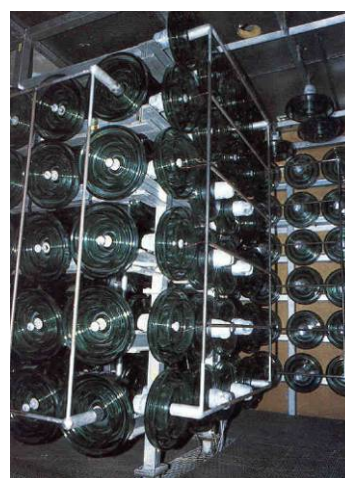
Figure 9 : Ionic migration test chamber

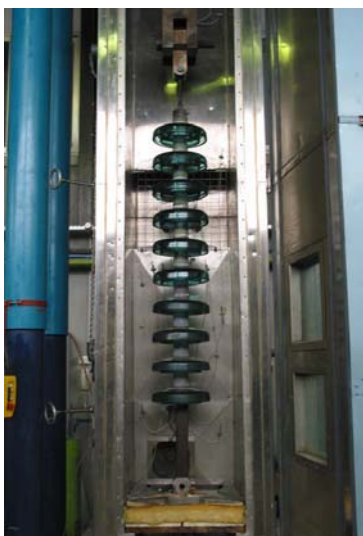
- All values above rating
- Average failing load 209.1kN
- Standard deviation : 10.8 kN
- Acceptance criteria : $1.2 \times 10.8 + 180 = 193$
- $\bar{X} > 193$ kN

Figure 10 : thermo mechanical test on HVDC Insulators removed after 30 years in service

The performance of old toughened glass insulators removed from HVDC lines was evaluated under reinforced conditions of thermal cycles.(temperature variations from -50°C to +50°C). The thermo mechanical test (figure 10) demonstrates full compliance with the standards applicable to new insulators.

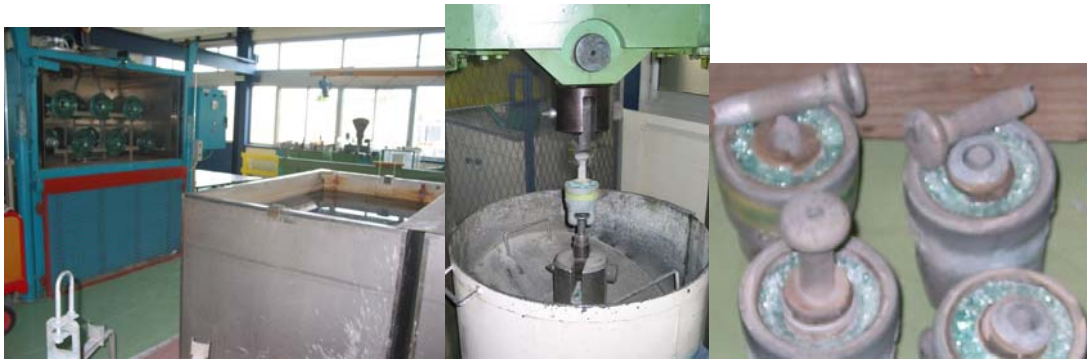
Figure 11 : Residual strength test after thermal cycles on 30 year old HVDC insulators

This test was performed on 15 insulators (rated 180kN) which had been in service for 30 years. The test conditions were according to IEC, therefore more severe than ANSI (see previous section for AC tests). 9 insulators broke at the pin. The lowest value of the pin breakage is 200 kN. For the others, 6 pins were pulled out, the lowest value being 176.1 kN. For these one, the calculation of the acceptance criteria is:

The residual strength of these old insulators tested as per IEC 60797 (figure 11) is above standard requirement, and quite equal to the rated value of new and intact insulators.

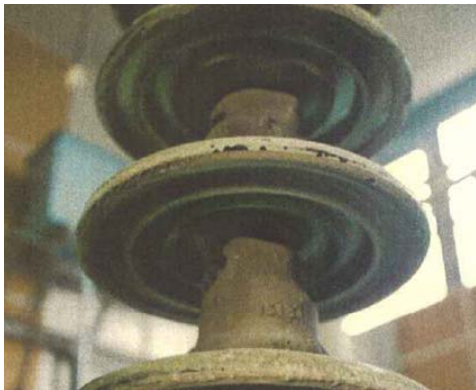
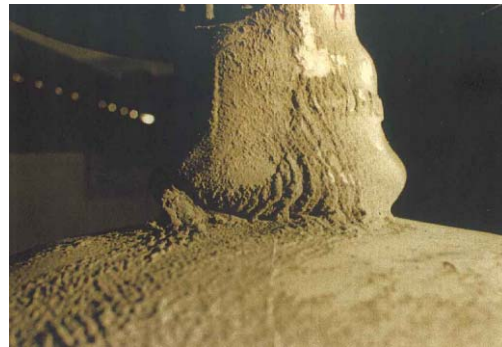
Toughened glass insulator ref. BS1513 after 27 years in Malaysia.

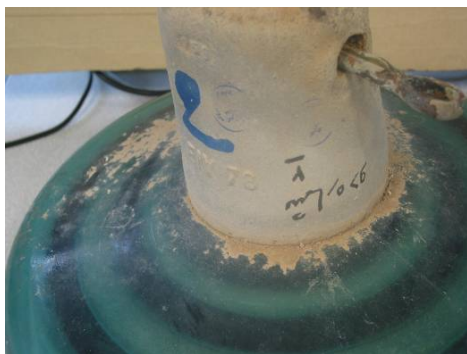
Toughened glass insulators ref U300 after 30 years in Iran

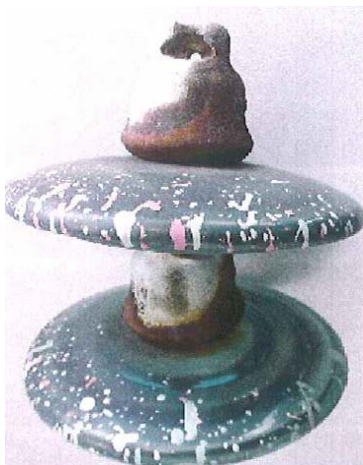
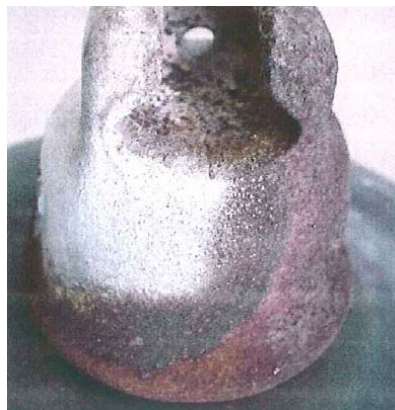
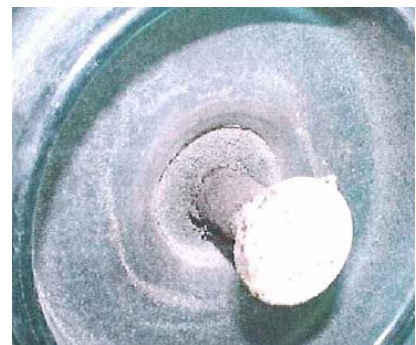
Toughened glass insulators Ref 1502 after 40 years in The Netherlands

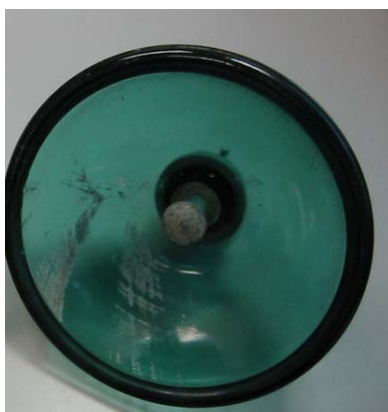
Toughened glass insulators Ref N14R2 after 30 years in the USA

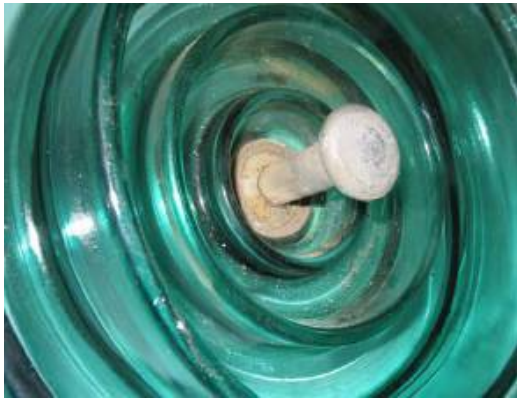
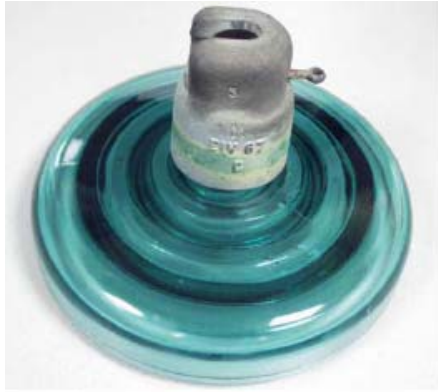
Toughened glass insulators Ref F18P after 30 years at 500kVDC in the USA

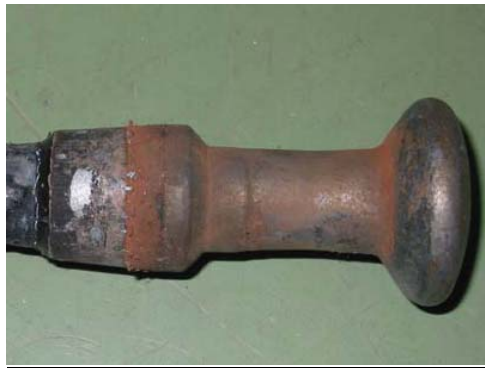
Toughened glass insulators Ref F16P after 25 years at 600kVDC in Itaipu Brazil. (second picture shows effective protection of zinc sleeve on a pin after being removed from an insulator.).

To support the explanation made earlier on the pin corrosion phenomena and the protection sleeve effect, it is interesting to see the effectiveness of such method for DC, which is even more prone to such corrosion phenomena. The samples taken from Brazil (Itaipu) show an excellent protection on the pin side, even after more than 20 years in tropical conditions.(see appropriate figures in appendix B). The corrosion seen on the cap on some samples had no influence to the mechanical performance. (DC insulators today have also a zinc collar on the cap for prevention of corrosion. Like for the pin, this feature was not used 20 years back).

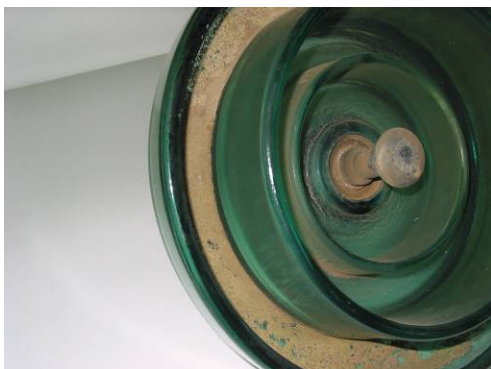
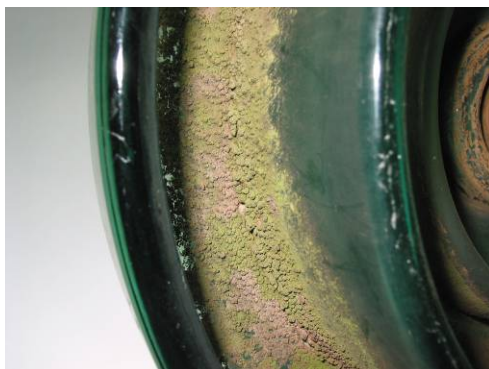
(pollution accumulation on Itaipu insulators was measured at ESDD of $0.4\text{mg}/\text{cm}^2$ and NSDD above $2\text{ mg}/\text{cm}^2$)
