ELECTRICAL CHARACTERISTICS AND PROPERTIES OF A STUB (DAMAGED TOUGHENED GLASS INSULATOR)

JM George^{1*}, S. Prat¹, S. Tartier¹ and Z. Lodi²

¹ Sediver S.A. R&D St Yorre, France

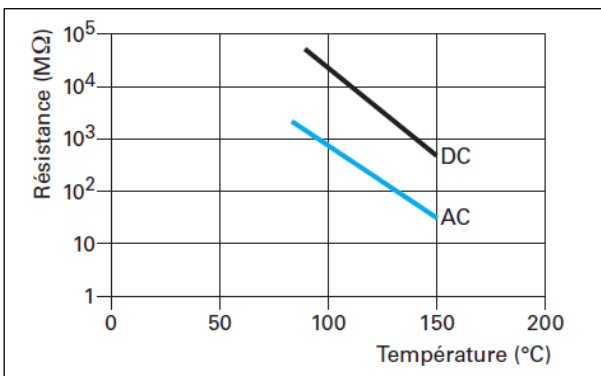
Figure 3: Example of body resistance measured at high temperature for AC and DC insulators as per IEC 61325 [8] [9].

Figure 3 gives an example of the body resistance of similar toughened glass insulators for AC applications and DC applications. To be correctly measurable, the resistance is tested at high temperature. The resistance of a typical insulator unit at ambient temperature can be estimated from 10GΩ to 500GΩ for AC and DC glass respectively. The difference in values between AC and DC is strictly the result of the bi-alkali effect in the chemistry used for the DC glass.

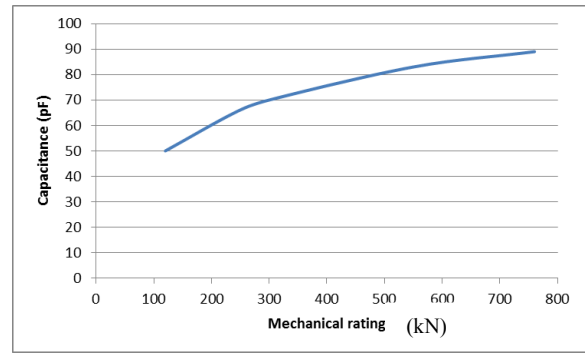
Figure 4: Example of capacitance values of toughened glass insulators.

A median value of C around 70pF can be considered for a complete glass insulator corresponding to a mechanically mid-range product, as can be seen in figure 4.

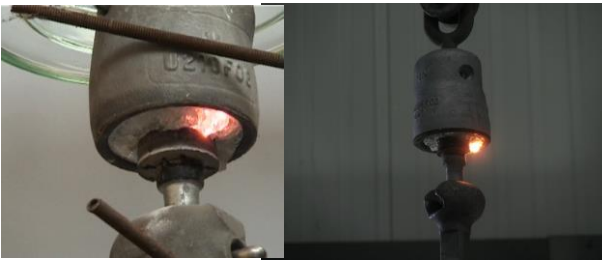
Figure 6: Flashover across the remaining section of broken glass of a stub. (Left AC, right DC).

Doing the same exercise with a stub requires the understanding that, once broken, the remaining glass stub will not see internal arcing during a voltage increase but rather flashover by an arc externally crossing the section of broken glass between the cap and the pin as can be seen in figure 6. This external air gap is short compared to the longer distance for an arc to find its way internally between the glass fragments compressed between the cap and the pin once the insulator is broken.

The thickness of the glass is slightly variable but in a narrow range (we will consider 12mm as a reference value), we can assimilate this external and constant distance to an air gap operating precisely as such. Tests have shown that 12kV is a typical discharge value for this phenomenon in AC in dry and clean conditions. For DC average values around 14kV were found for both polarities. The capacitance and resistance of the stub will be changed by the fact that the glass is broken. We can therefore consider that both C and R will change leading to the equivalent electric circuit shown in figure 7.

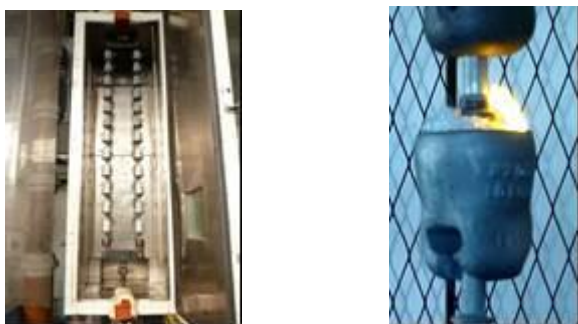
Figure 10: Left: Thermal mechanical test on stubs. Right: electromechanical test at 70% of rating.

Full strings of stubs have been tested in thermal mechanical conditions corresponding to the most severe testing conditions [10] as shown in figure 10.

Applied load was 70% of the rating, temperature cycles were from -50°C to $+50^{\circ}\text{C}$. After thermal mechanical stresses were applied all the stubs were electrically tested resulting in systematic external flashover.

In a final stage, all stubs were electrically tested under a permanent mechanical load of 70%, again leading to systematic external flashover.

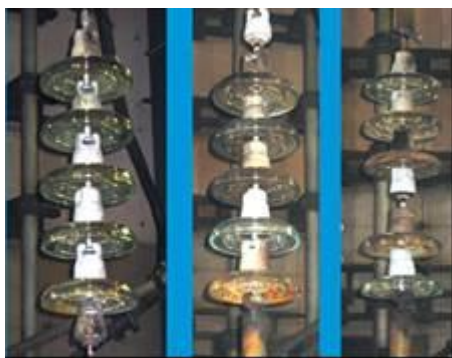
Figure 12: Strings with stubs after power arc testing.

Stubs were subjected to a power arc following the set up and test conditions of IEC 61467 [11]. The tests were performed simulating various configurations of a string made of 6 units. The stub was placed once at the bottom, once in the middle and once at the top of the strings. Each string was submitted to two consecutive shots of $6\text{ kA}/0.2\text{ s}$. The same test was performed with strings which stubs had previously been immersed for 48h in a 10 g/l salt solution. An additional test of 6 consecutive shots was made on a string constituted only of 6 stubs.

Figure 12 shows the tested strings. Figure 13 shows the string made of 6 stubs during the power arc. The presence of 6 separate arcs crossing the external distance outside the stubs indicates clearly that the stubs do not behave like punctured discs, and as such illustrates clearly the difference with porcelain discs which, once punctured, could lead to a string separation resulting from internal arcing along the puncture path leading to excessive energy accumulation inside the cap.

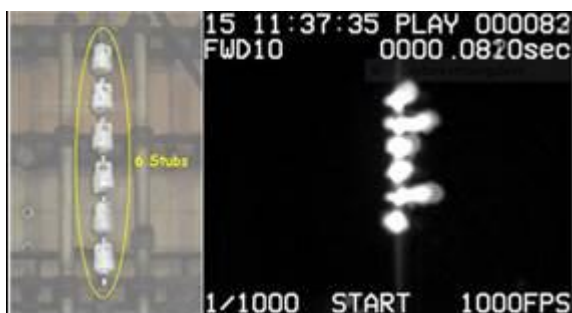
Figure 13: String of stubs during a power arc test showing systematic external arcing.

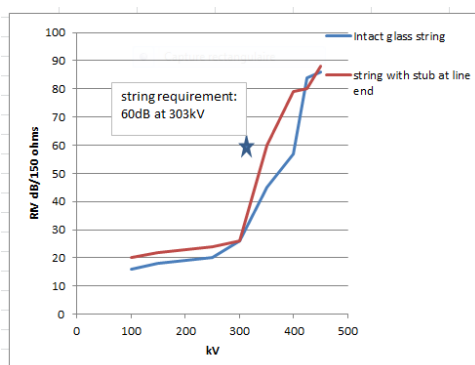
Figure 16: RIV results of a 500kV string containing a stub in the glass string at the live end.

The following RIV test was performed according to ANSI C29-1 [14] on a 500kV string made of 25 ANSI 52-5 glass units, equipped with normal hardware configuration, having a stub at the live

end. At nominal voltage the RIV levels are similar both with or without a stub.
