# Coating...of Course

Jean Marie George  
Dr. Sandrine Suc  
Fabien Virlogeux  
SEDIVER

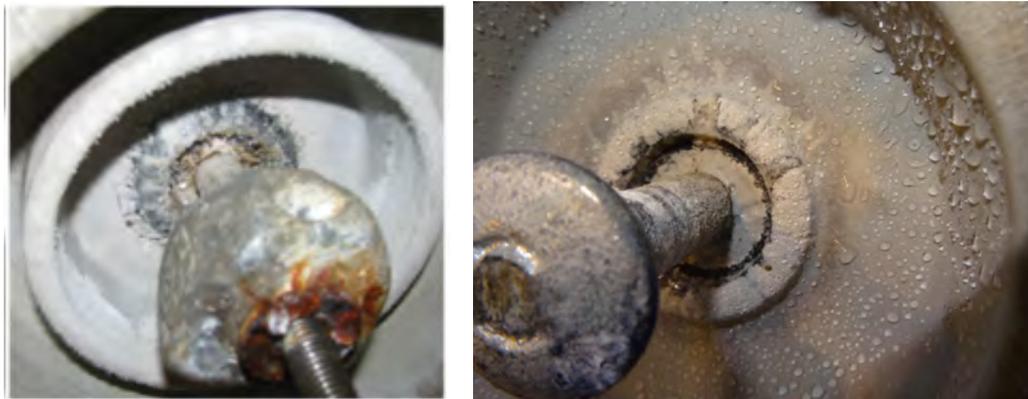
**Figure 2:** Erosion on 2 different coatings in a 1000h salt fog test with a USCD=25mm/kV

This test which is described in IEC 61109 [5] depends largely on the USCD that is being used and the insulator profile. A test performed at 8g/l with a USCD= 34mm/kV does not show any damage to any coating while the same shape tested at USCD=25mm/kV will damage the coating whatever it is (figure 2). This test designed for polymer has one flaw if it is used for coatings: the thickness of the coatings is around 350µm while polymers are being tested to establish their resiliency with thicknesses at or above 3mm. This test is not adapted to the objective of selecting a coating.

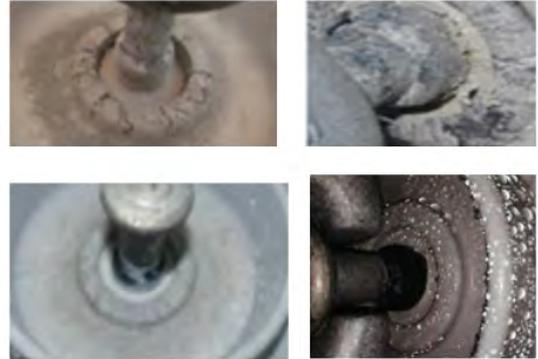
**Figure 6** : Typical results showing erosion among coating chemistries

Figure 5 shows the set up for this test and figure 6 shows different types of results as a function of the nature of the chemistry and application of the coating. This test has proven to be effective in discriminating coatings prone to erosion compared to good survivors under the given stress conditions.

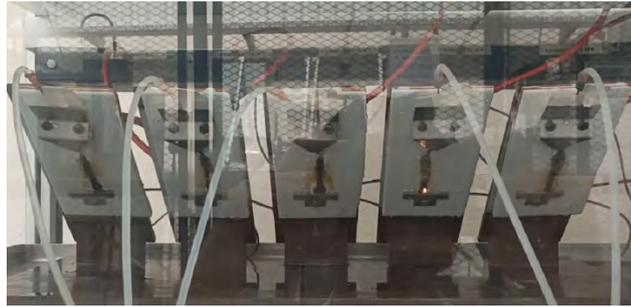
**Figure 7 :** Set up of the test

To illustrate this point figures 7 and 8 show typical results which all are considered as acceptable since the only criteria in the protocol of CIGRE 478 is that the tile should not break...but erosion is not considered as a criterion by itself. In other words, given the fact that erosion will take place anyway the only difficulty in this test is to find a ceramic tile strong enough not to break. It is not testing the coating.

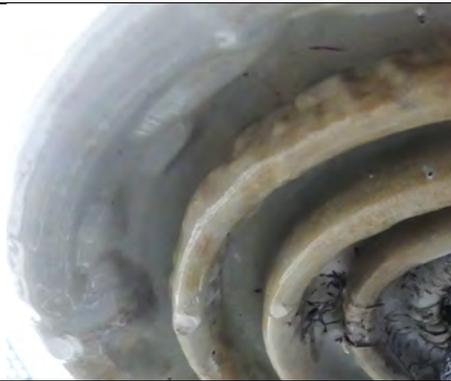
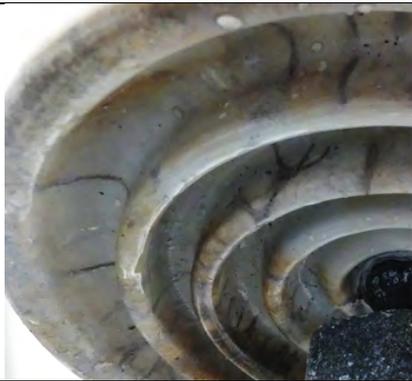
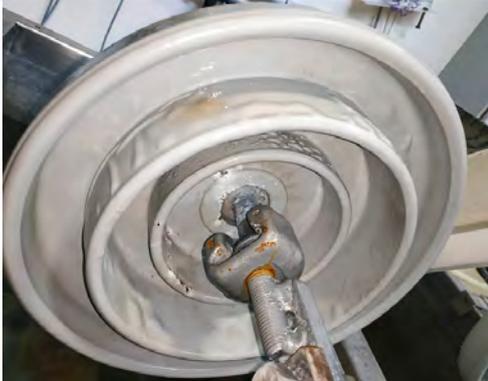
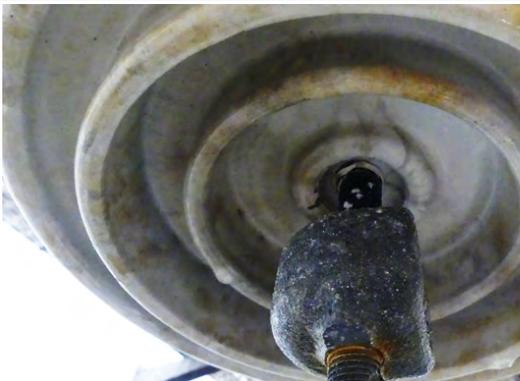
<p>Large loss of adherence of silicone type A on porcelain insulator (8000 cycles)</p>	<p>Better adherence of silicone type B on porcelain insulator (13000 cycles)</p>

<p>Areas with lack of adherence on glass insulator with silicone type A after 14000 cycles</p>	<p>Good adherence with silicone type B on glass after 24000 cycles.</p>

**Figure 12:** Adherence of the coating for porcelain and glass insulators with silicone type A and type B

- a. Adherence of the coating on the dielectric is being challenged as it is always the case when a thin layer of silicone is immersed for some time in water. Some samples will display large bubbles some will not and not at the same time depending mostly on the nature of the silicone coating and the application process (figure 12).
- b. For some samples the adherence is completely recovered after a rest time following the end of the test. Approximately 24h of rest time for the best candidates (Figure 13). It seems also that while all samples were coated with similar care of adherence, porcelain is more inclined to lose adherence than glass.

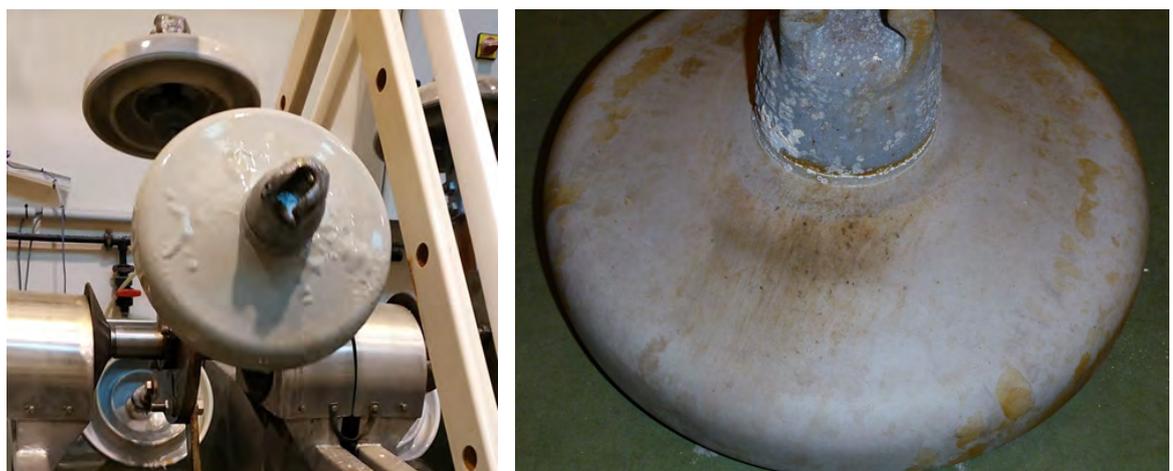
**Figure 13:** Loss of adherence of silicone type B after 28000 cycles on glass Insulator (left). The same Insulator 24h after the end of more than twice the test duration (65000 cycles)

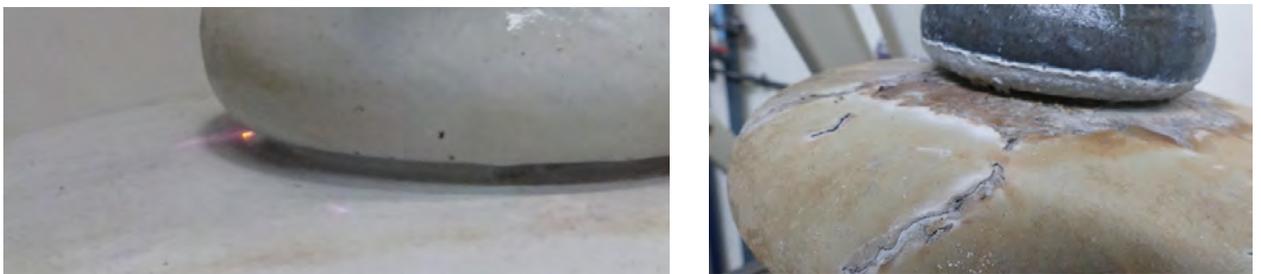
Figure 14 : Electric activity on porcelain after approximately 7000 cycles (left) and erosion as of approximately 13000 cycles on porcelain with type A silicone.

The top behavior is strongly influenced by the assembly of the cap on the dielectric. A gap between the base of the cap and the upper surface of the disc will favor discharge activity leading progressively to severe erosion as shown in figure 14 disregarding the type of silicone.

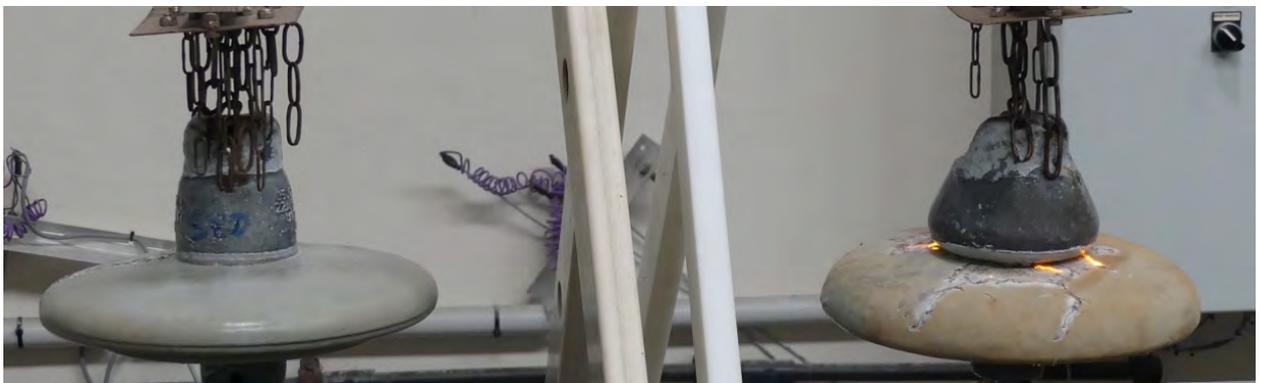
Figure 15: Comparison of dry band arcing activity at the base of the cap of Sediver glass having a flock at the base of the cap and a porcelain insulator. (Silicone type A at 10000 cycles).

- c. The development of dry band arcing over time intensifies as hydrophobicity is being lost or reduced. This increase of electric activity is significantly more severe for the porcelain discs (figure 15), most probably due to the design of the porcelain ribs.

This is a phenomenon less prone to take place when the cap is sealed on the glass with a flock as per Sediver glass insulators design (Figure 15).

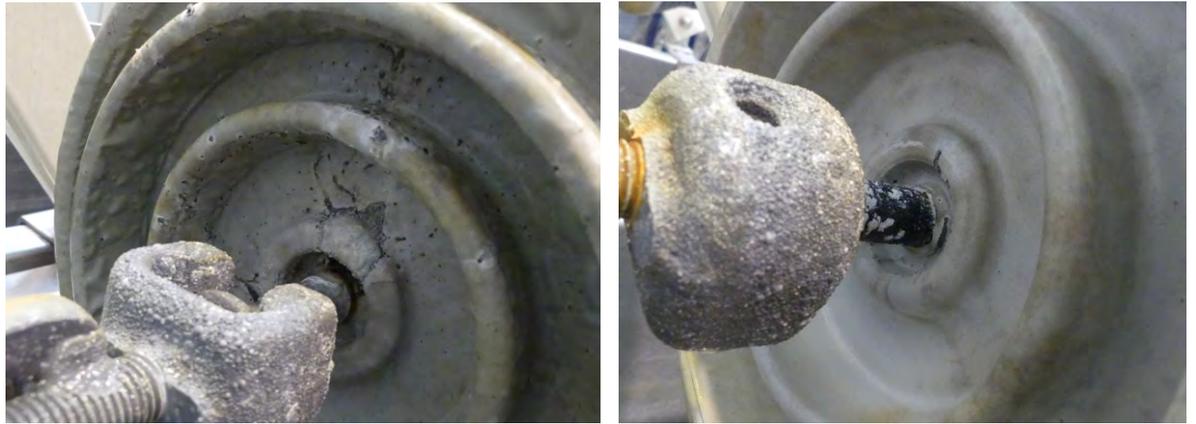
Figure 16: Glass insulator at approx. 20000 cycles. Left silicone coating type A, Right Silicone coating type B

- d. The bottom sides of the insulators are typically more impacted given the concentration of activity around the pin. This is where the nature of the silicone itself can make a difference as shown in figure 16.
